Holiday Inn Birmingham Bromsgrove

Guide Last Updated: 20/10/2017

Access Guide

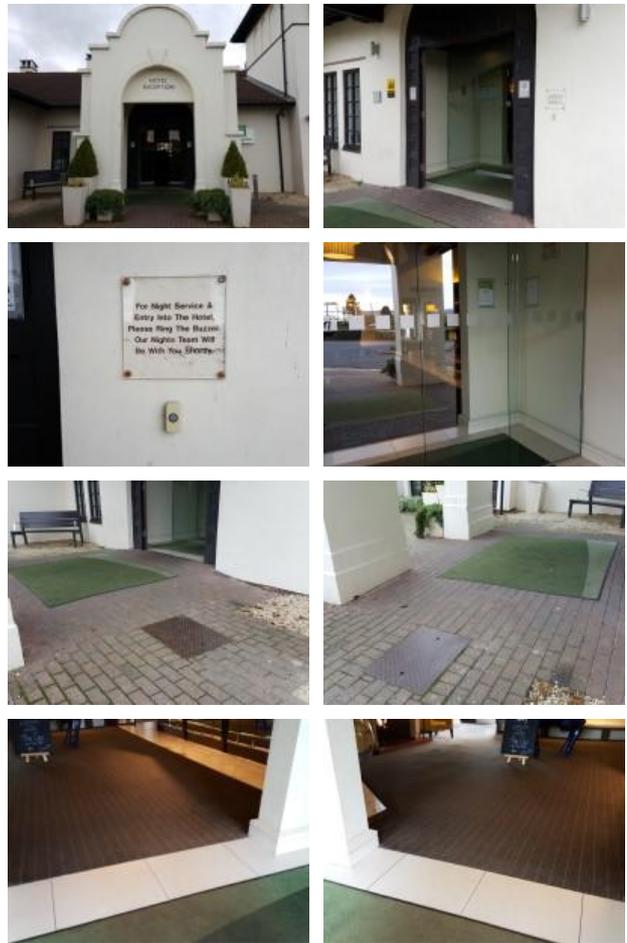
- This information is for the entrance located at the front of the hotel.
- The entrance area/door is clearly signed.
- There is ramped/sloped access at this entrance.
- There is a canopy or recess which provides weather protection at this entrance.
- The entrance door(s) does/do contrast visually with its immediate surroundings.
- The bell/buzzer is not in a suitable position to allow wheelchair users to gain access.
- The height of the bell/buzzer is 126cm (4ft 2in).
- The main door(s) open(s) away from you (push).
- The door(s) is/are double width.
- The door(s) is/are permanently held open.
- The width of the door opening is 164cm.
- There is a second set of doors.
- The door(s) open(s) automatically.
- The door(s) is/are double width.
- The width of the door opening is 127cm.
- There is a member of staff available for assistance at this entrance.

- The ramp/slope is located in front of the entrance and immediately beyond the second set of doors.
- The gradient of the ramp/slope is slight.

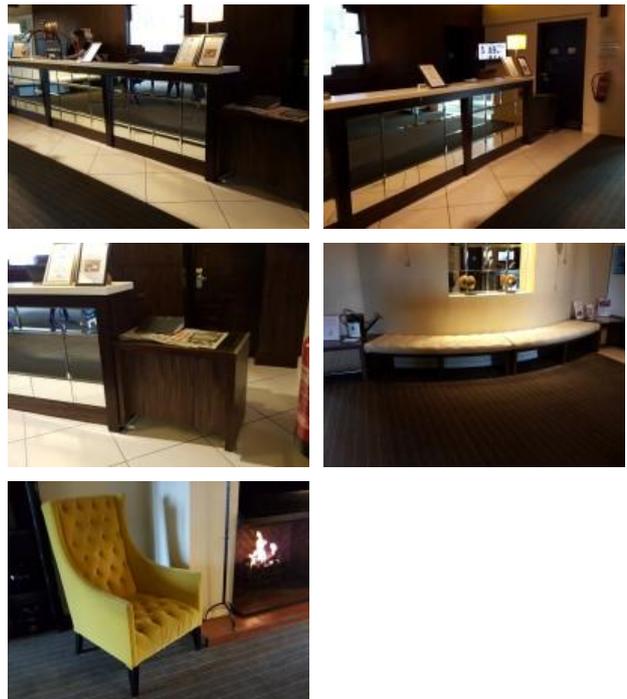
- The reception point is located to the right as you enter the hotel entrance.
- The reception point is approximately 3m (3yd 10in) from the hotel entrance.
- The reception area/desk is clearly visible from the entrance.
- There is step free access to the reception point.
- There is a clear unobstructed route to the reception point.
- There are windows, TVs, glazed screens or mirrors behind the reception point which could adversely affect the ability of someone to lip read.
- The reception counter is not placed in front of a background which is patterned.
- The lighting levels at the reception point are low.
- The height of the reception counter is high (110cm+).
- There is sufficient space to write or sign documents on the counter.
- There is a lowered section of the counter.

- The lowered section of the counter is not at the recommended height of 76cm.
- There is sufficient space to write or sign documents on the lowered section of the counter.
- There is not a clear knee recess beneath the lowered section of the counter.
- The counter is staffed.
- Clipboards can be provided to anyone who is unable to use the desk.
- There is a hearing assistance system at the reception point.
- The type of system is a fixed loop.
- The hearing assistance system is not signed.
- Staff are trained to use the system.
- Signs and universally accepted symbols or pictograms, indicating lifts, stairs, WCs, circulation routes and other parts of the building are provided in the reception area.
- The type of flooring in the reception area is carpet and tiles.

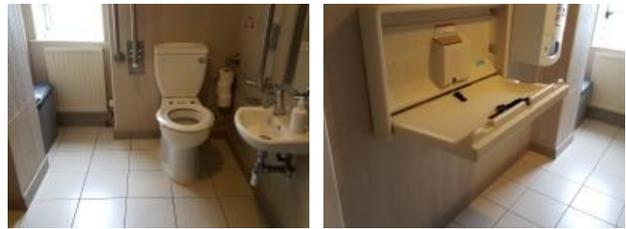
- This accessible toilet is located in the right hand corridor just past reception.
- This accessible toilet is approximately 14m (15yd 11in) from the hotel entrance.
- There is step free access to the accessible toilet.
